DA Mechanical Services

Infrared Inspection Report

A. BCD Inc.
123 West 110th Street
Anytown, PA 01234

Distribution Panels
Motor Control Centers

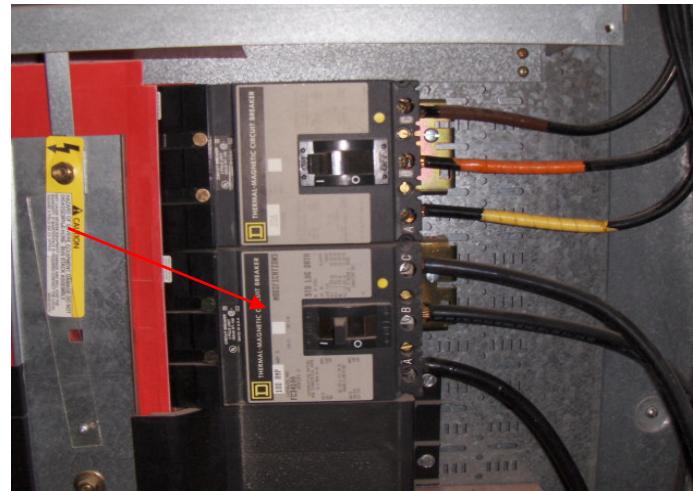
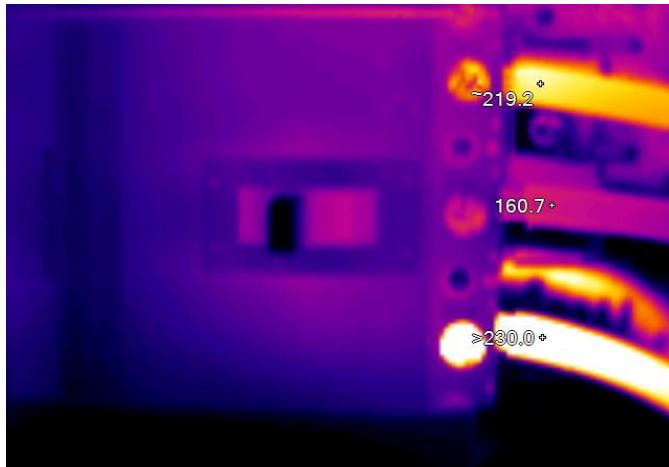
No.: 1
Job-No.: X85-7854
Date: 11/5/2005

Location: A. BCD Inc.
Room / Building: Boiler Room Equipment: EMPD - Breaker Exhaust Fans 1-7

Rated Load: 100 A Measured Load: 95.0 A
% Load 95 %

Ampere Phase A 91.0
Ampere Phase B 92.0
Ampere Phase C 95.0

Ambient Temp.: 20 °C
Comments: Reduce load, check connections, check wiring etc. Breaker tripped after ampere measurement.

Obj. Priority: 1 Subj. Priority: Avg. Priority:

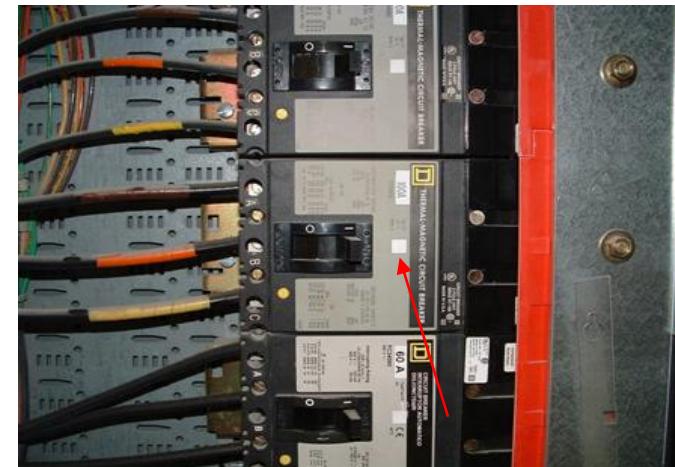
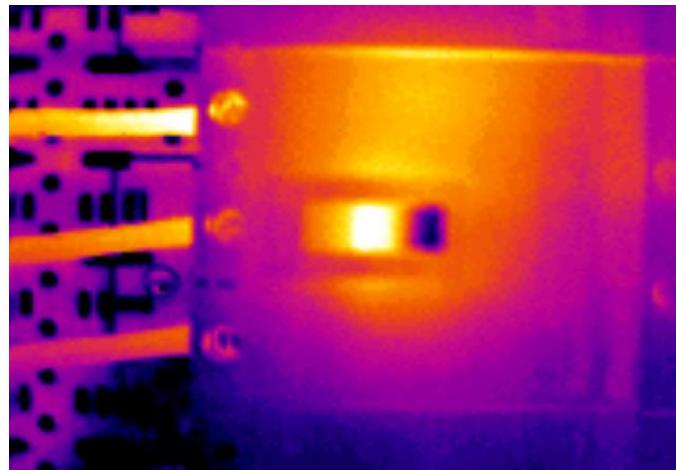
No.: 2
Job-No.: X85-7854
Date: 11/5/2005

Location: A. BCD Inc.
Room / Building: Process Room A Equipment: DP2 - Breaker #9

Rated Load: 100 A Measured Load: 36.0 A
% Load 36 %

Ampere Phase A 36.0
Ampere Phase B 34.9
Ampere Phase C 34.5

Comments: 5 C temperature difference between Phase A to C. Check load, connections etc.

Obj. Priority: 3 Subj. Priority: Avg. Priority:

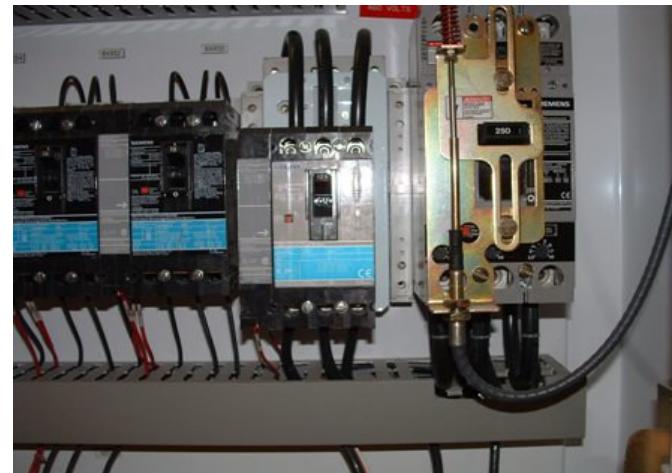
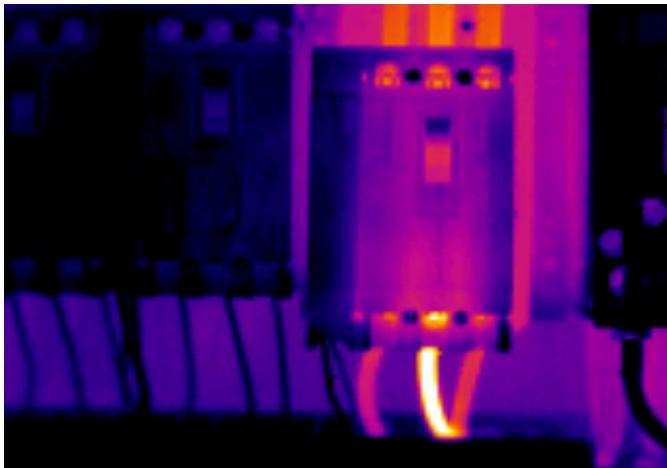
No.: 3
Job-No.: X85-7854
Date: 11/5/2005

Location: A. BCD Inc.
Room / Building: Process Room A Equipment: MCC-5 Blower Panel Breaker M35

Rated Load: 100 A Measured Load: 51.0 A
% Load 51 %

Ampere Phase A 48.0
Ampere Phase B 51.0
Ampere Phase C 49.0

Comments: 4 C temperature difference between Phase A to B. Check load, connections etc.

Obj. Priority: 3 Subj. Priority: Avg. Priority:

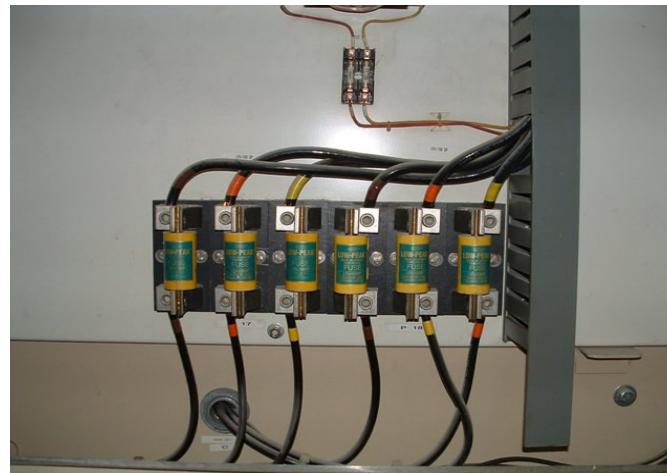
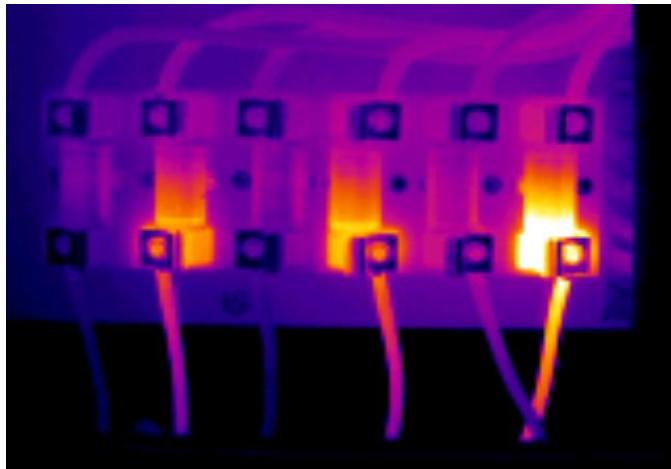
No.: 4
Job-No.: X85-7854
Date: 11/5/2005

Location: A. BCD Inc.
Room / Building: Process Room A Equipment: Cutter Panel Fuse

Ampere Phase A 23.0
Ampere Phase B 22.0
Ampere Phase C 23.0

Comments: Fuse 2, 4 & 6. Check connections and clean connections.

Obj. Priority: 3 Subj. Priority: Avg. Priority:

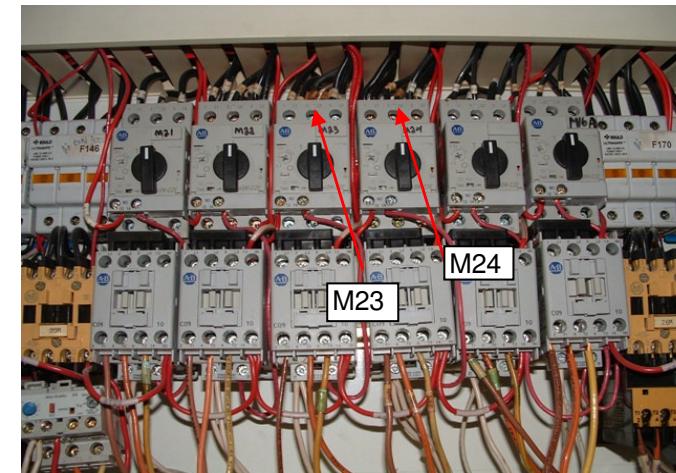
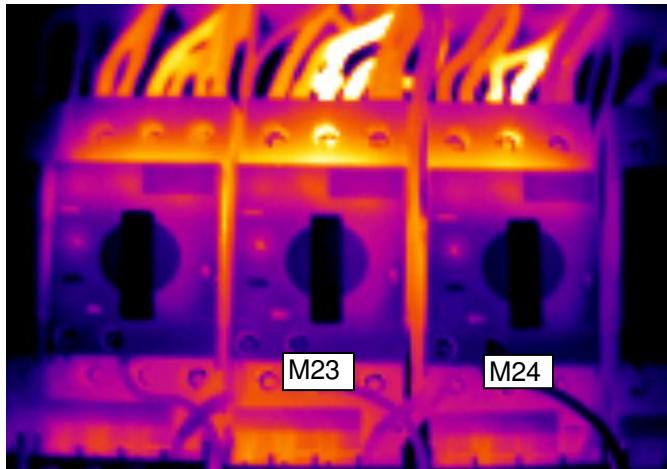
No.: 5
Job-No.: X85-7854
Date: 11/5/2005

Location: A. BCD Inc.
Room / Building: Process Room B Equipment: MCC-6 Disconnect M23

Rated Load: 10 A Measured Load: 7.2 A
% Load 72 %

Ampere Phase A 7.2
Ampere Phase B 7.0
Ampere Phase C 7.1

Comments: Check load, connections etc.

Obj. Priority: 3 Subj. Priority: Avg. Priority:

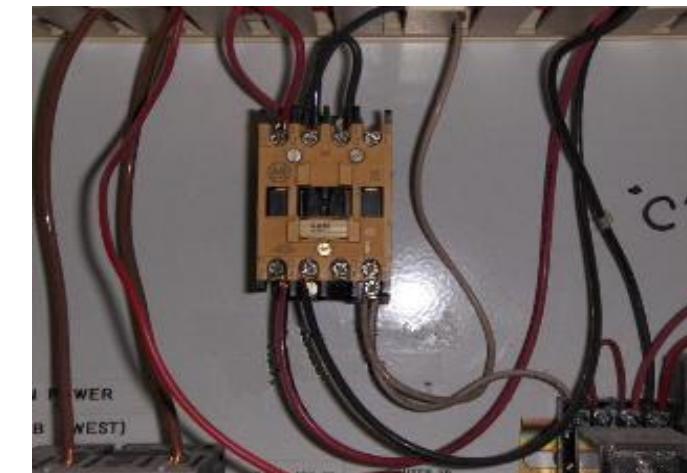
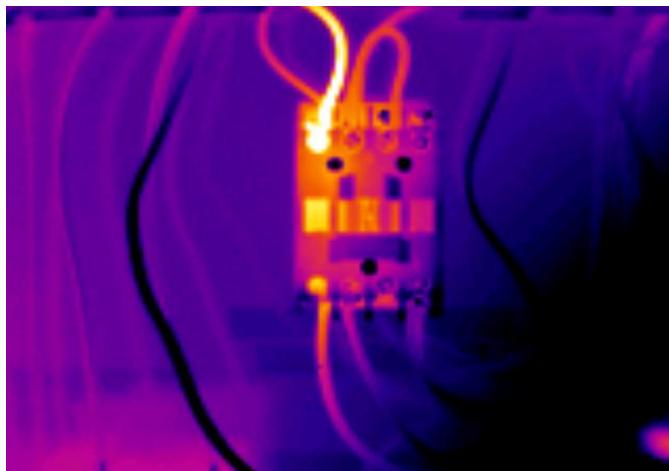
No.: 6
Job-No.: X85-7854
Date: 11/5/2005

Location: A. BCD Inc.
Room / Building: Process Room B Equipment: MCC-4 Drum Contactor M54

Rated Load:	A	Measured Load:	4.5 A
		% Load	%
Ampere Phase A	4.5		
Ampere Phase B	4.2		
Ampere Phase C	4.1

Comments: Check load, connections etc.

Obj. Priority: 3 Subj. Priority: Avg. Priority:

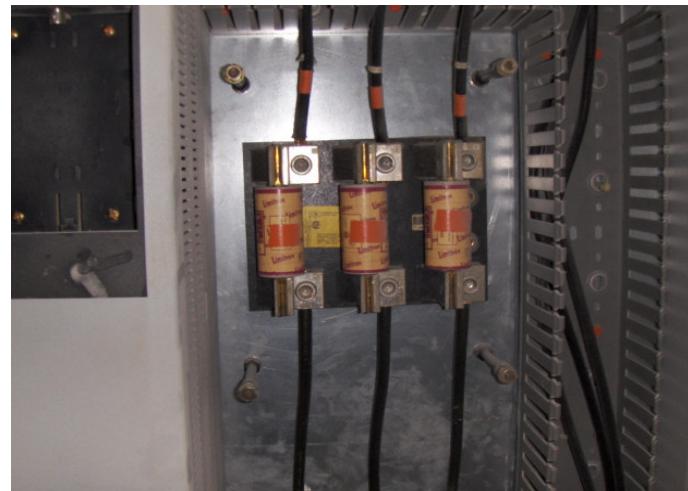
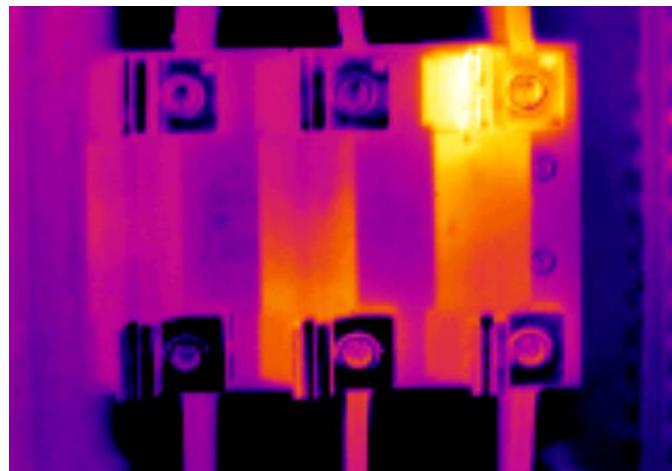
No.: 7
Job-No.: X85-7854
Date: 11/5/2005

Equipment: MCC-3 Conveyor Panel Fuse

Rated Load: A Measured Load: 25.0 A
 % Load %

Ampere Phase A 25.0
Ampere Phase B 23.0
Ampere Phase C 23.0

Comments: Check connections, clean connections

Obj. Priority: 3 Subj. Priority: Avg. Priority:
